STRUCTURAL EVALUATION OF UH-1D TUBULAR
ROTOR BLADE

Fiber Science, Incorporated

Army Air Mobility Research and
Development Laboratory

August 1974

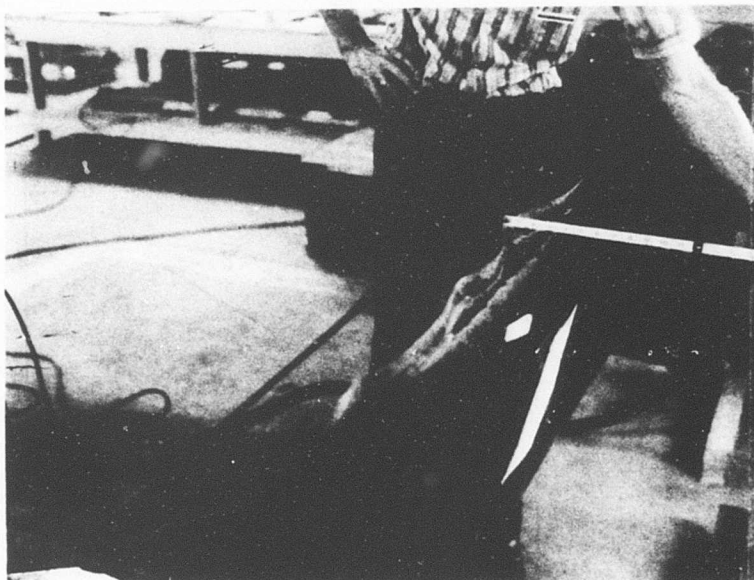
The blades were subjected to 150% of limit flapwise and chordwise bending and torsional loads except for the chordwise loading portion on Blade S/N 001. During the chordwise portion of the test on S/N 001, the blade failed at a loading of 1650 pounds. When the 1650-pound load was reached, audible cracking noises were heard coming from the general area toward the root end third of the blade. Application of the loading was stopped and the blade was observed. More cracking was heard and the trailing edge around Station 50 became unstable and took a serpentine shape. This condition progressed for about 5 seconds and then the trailing edge separated suddenly with a loud bang. Separation occurred in the material near the bond line and also in the foam beginning at 27.5 inches from the root end and extending to 84.5 inches from the root end. The total length of the split was 57 inches. The foam separation depth varied from very little at both ends of the split to a maximum of 15 inches at a point approximately 55 inches from the root end (midway between split ends).

Figure 27 is a photograph of the damage as seen during post failure flapwise static deflection tests.

Figure 27. Chordwise Proof Test
Failure - S/N 001.

The blade was very simply repaired by pouring a mixture of resin into the separation area and then clamping the area closed using a vacuum bag around the blade. Resin was also injected into the fringes of the damaged area where the poured resin could not reach.

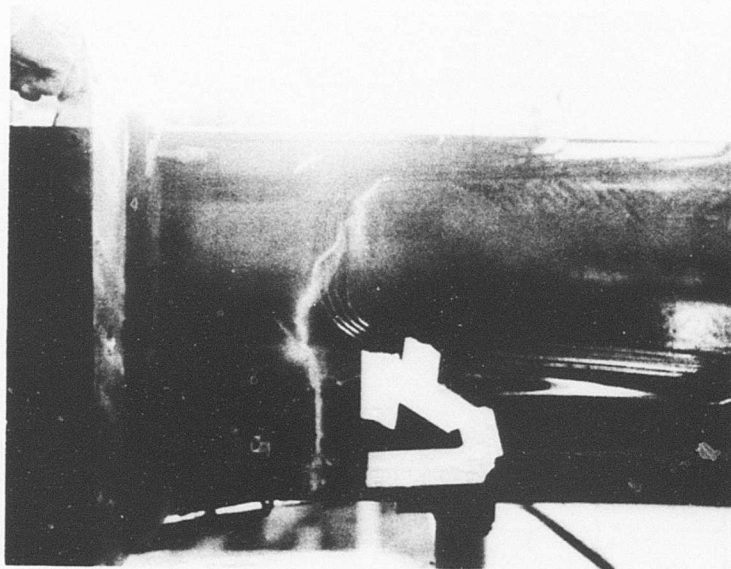
Blade S/N 002 withstood 450, 000 cycles at a strain of +.000920 in. /in., 167, 076 cycles at a strain of +.001200 in. /in., 350, 000 cycles at a strain of +.001670 in. /in., and 29, 376 cycles at a strain of +.002360 in. /in. The +.001200 level was performed in error. At 29, 376 cycles of the high level (+.002360 in. /in. strain) test, a fatigue failure appeared in the root end 5 inches from the center of the 2.5-inch pin hole toward the blade tip (see Figure 31). Testing was continued for an additional 116, 000 cycles until failure progressed to the point where vibration could no longer be effectively induced. A total of 1.112×10^6 cycles was accumulated on the blade. The blade natural frequency in this mode was 17 Hz before the failure. After the failure, it was 15 Hz and gradually reduced to 13 Hz when the test terminated.

It was noted during the testing of S/N 002 that the laminated area around the large pin moved in a breathing motion relative to the pin. Displacement was approximately 0.25 inch. This motion probably occurred on all blades, at least to some extent. Reasons for this include the method of mounting the blade and also the fit of the large pin. A bolt instead of the pin allowing a clamping attachment would probably not have allowed damage to occur. The pin in Blade S/N 003 (blade not damaged) fitted tighter than the pins in the other two blades. The damage to the two blades is attributed to these two factors and the high strain test levels.

Figure 31. Fatigue Test Damage - S/N 002.

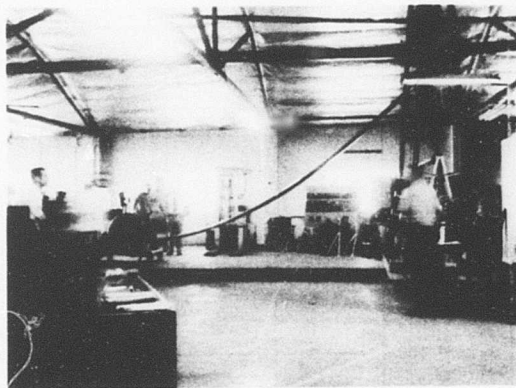
S/N 003's first major break occurred at a tip height of 120 inches and a loading of 975 pounds. The break consisted of skin compression failure at Station 84 and leading edge split from Station 35 to Station 76. When the break occurred, the load dropped immediately back to 850 pounds. Testing was continued to a height of 132 inches and 1100 pounds. At this time, the trailing edge split open from Station 48 to 96 and the load dropped to 950 pounds (see Figures 34 and 38).

Figure 34. Ultimate Test -
Maximum Loading
at Break -
S/N 003.

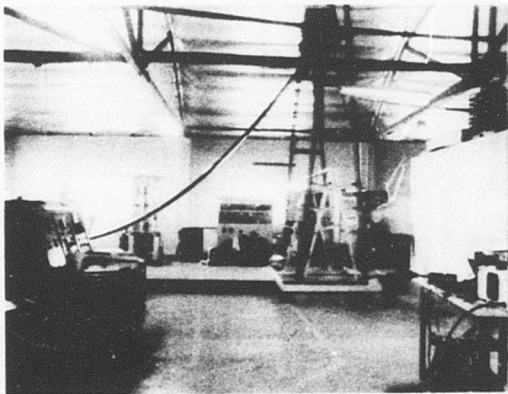
S/N 002 ultimate testing was terminated at a tip leading edge height of 144 inches above zero and a loading of 915 pounds. The test was terminated at this point because the blade was hinging at the damaged section of the root end sustained during fatigue testing (see Figures 35 and 37).

Figure 35. Ultimate Test -
Maximum Loading
at Break - S/N 002.

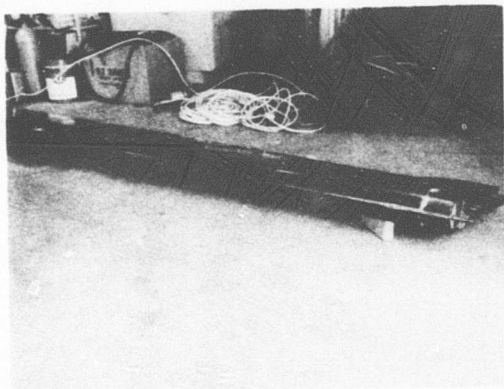
S/N 001 failed at a tip height (leading edge) of 10 feet above the zero position with a loading of 750 pounds. Failure occurred in the root end beginning at the damaged area incurred during fatigue testing. The failure line began at the center of the 2-1/2-inch-diameter hole, progressed straight to the leading edge, made an abrupt right angle turn at the seam in the leading edge, and progressed toward the tip for about 2-1/2 feet. The load after breakage dropped to 600 pounds (see Figures 33 and 36).

Figure 36. Ultimate Test
Failure -
S/N 001.

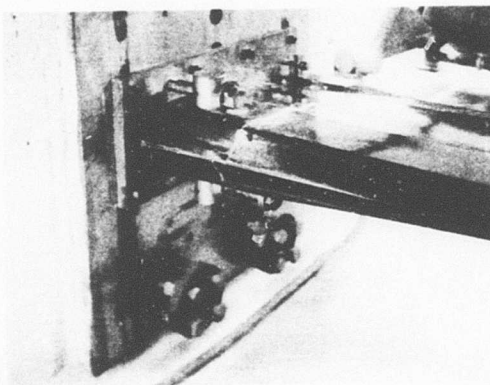
Figure 37. Ultimate Test
Failure -
S/N 002.

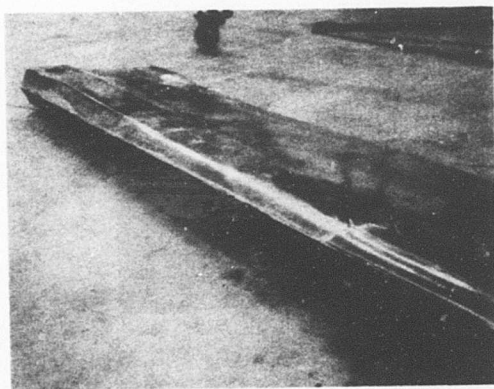
Figure 38. Ultimate Test
Failure -
S/N 003.

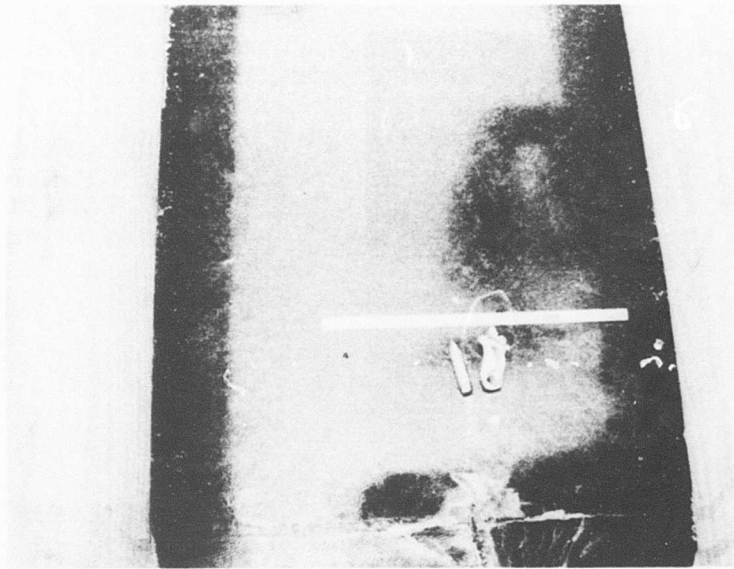
Figure 39. Bullet Impact, Leading
Edge - S/N 002.

The bullet hit flat on the leading edge of the blade and glanced off into the sand. The damage to the blade was groove shaped, penetrating the skin and gouging out a small area in the surface of the longo material. The groove was approximately 1-1/2 inches long, 1/2 inch wide and 0.30 inch deep. Damage to the skin was approximately 2 inches chordwise and 3 inches spanwise.

1. All damaged material was removed by sanding with an air-operated hand-held rotary disc sander using 60-grit Jewelox paper. At the same time, the sides of the groove in the longo material were tapered out to 3 inches in the spanwise direction. The skin material was then stepped (2 steps, each 1/2 inch wide) past this point.

2. The longo material was replaced using plies of Style 143 fiber glass fabric and a resin system consisting of DOW DER 323 resin and APCO 320 hardener at a ratio of 17.4 parts by weight per hundred. The resin system was applied to each ply of fabric to assure full saturation. The first plies were cut small to fill the bottom of the groove, and each succeeding ply was cut increasingly larger to fill the groove evenly. Twenty plies were required to fill the groove in the longo material.

3. The skin material was replaced using six plies of Style 181 fabric with the fibers placed at an angle of $\pm 45^\circ$, and two plies of the same material with the fibers at 0° to the spanwise axis. Again, the same procedure was used of cutting smaller pieces at first and increasing the width and length to fill the hole evenly. The last two plies covered the entire hole, overlapping on each side 1 inch onto the outer surface of the original skin. The same resin system described in Step 2 above was used.

4. Next, the entire repaired area was covered with one ply of Style 113 fabric using the same resin system, and overlapping 2 inches on each side.
5. The entire area was vacuum bagged (28 in. Hg) and cured under heat lamps at a temperature of 200° F for 4 hours.
6. After curing, the vacuum bag was removed, was sanded to remove excess material and formed to the original shape. Progressively finer sanding discs were used to finish the area, beginning with a No. 60 grit air-operated sander and ending with a No. 400 grit hand-held block sander.
7. The entire repair area was then covered with a plastic coating used to restore the natural surface appearance of glass-reinforced plastic structures.
8. The repair required 6 hours including cure time. The cure time was 4 hours.

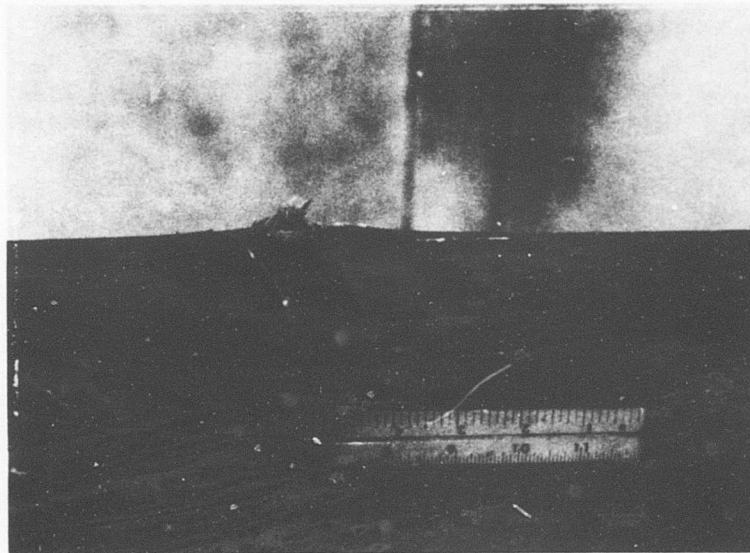
Figure 40. Bullet Impact, Trailing
Edge - S/N 002.

The bullet penetrated the trailing edge of the blade and exited on the opposite side, leaving a groove running chordwise for about 1-1/2 inches long at the entrance and about 3 inches long on the exit side. The trailing edge split at the bond line approximately 4 inches on both sides of the bullet entrance. The bullet severed the trailing-edge longo material, and the damage extended forward into the foam area.

1. The skin was stripped away on both sides of the blade until the trailing edge longo material and foam were exposed for 7-1/2 inches on both sides of the damaged area and 1 inch in front. The resulting exposed areas were rectangular in shape. Using an air-operated disc sander with No. 60 grit paper, the skin was tapered back 1-1/2 inches on each side of the rectangles.
2. Again, using the sander, the damaged longo material was removed and the two severed ends were sanded to a knife edge taper on the ends with the taper extended back 2 inches on the bullet entrance side and 4 inches on the bullet exit side.
3. Voids in the damaged foam area were filled using a thick mixture of micro-balloons in a resin system composed of DOW DER 332 resin and APCO 320 hardener mixed to a ratio of 17.4 parts by weight per hundred.

The material when folded in this fashion formed the same shape as the wedge-shaped longo material and at the same time generally fit the contoured sides of the cleaned-out damaged area.
7. Four plies of Style 181 glass cloth were installed over the 46 plies of the Style 143 cloth in the same manner as described in Step 4.
8. One ply of Style 113 cloth was installed over the entire area in the same manner as described in Step 5.
9. The entire area was vacuum bagged (28 in. Hg) and cured under heat lamps at a temperature of 200°F for 4 hours.
10. After curing, the vacuum bag was removed, and the area was sanded to remove excess material and formed to the original shape. Progressively finer sanding discs were used to finish

11. The entire area was then covered with a plastic coating to restore the natural surface appearance of a glass-reinforced plastic structure.
12. Repair required 4 hours plus another 4 hours for cure.

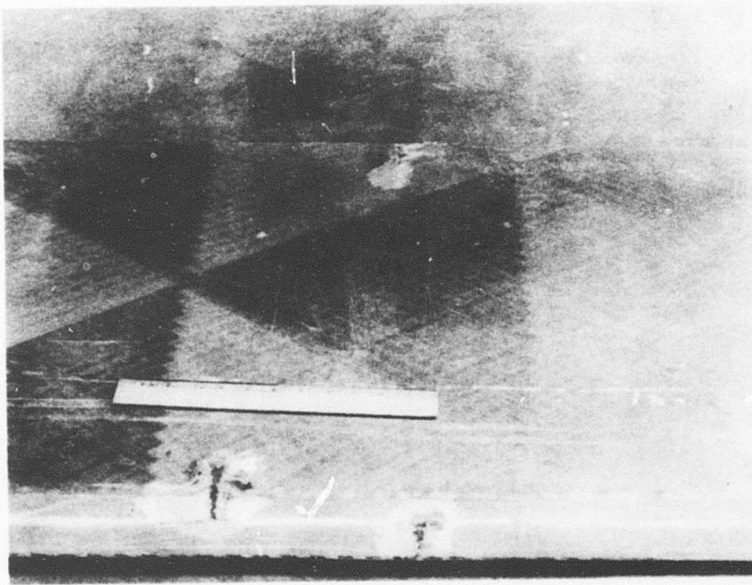
Two bullets were fired into the leading edge of S/N 003. This first round, fired at a velocity of 1800 feet per second, caused less damage than expected (see Figure 39) so a round was fired at 2500 feet per second. In both cases the bullets cut the skin and glanced off the longo material, leaving a shallow groove. The higher velocity round resulted in noticeably more damage to the surrounding skin (see Figures 41 and 42).

Figure 41. Bullet Damage,
Spar - S/N 003.

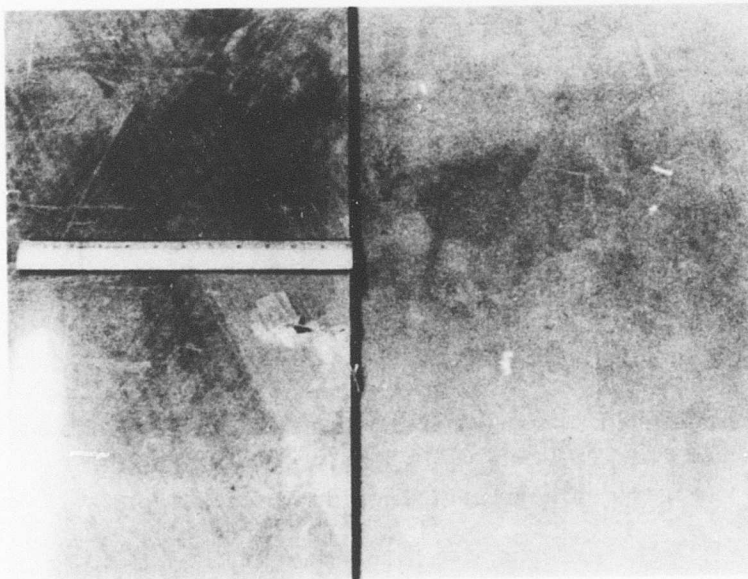
The bullet fired into the trailing edge on Blade S/N 003 penetrated through the blade and lodged, partially exposed, on the back side. The bullet hole was 3.3 inches long on the entrance side and 4.9 inches long on the exit side. The damage extended to a width of approximately 1.5 inches on each side of the hole.

Figure 42. Bullet Damage,
Trailing Edge - S/N 003.

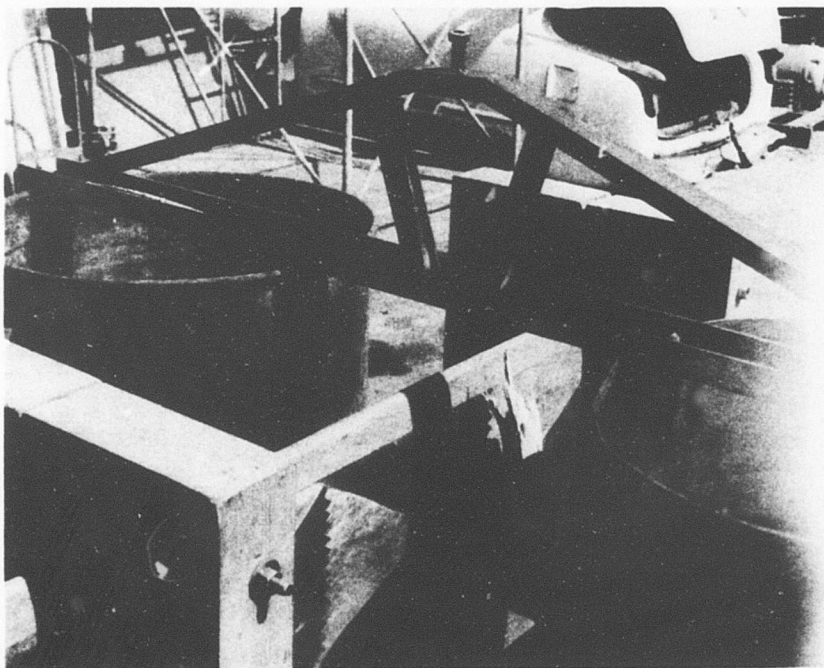
No damage was sustained by either of the two blades tested as a result of the tree strike tests (see Figure 43). The blades have excellent resistance to damage from simulated tree strikes.

Figure 43. Impact Tree Strike - S/N 003.

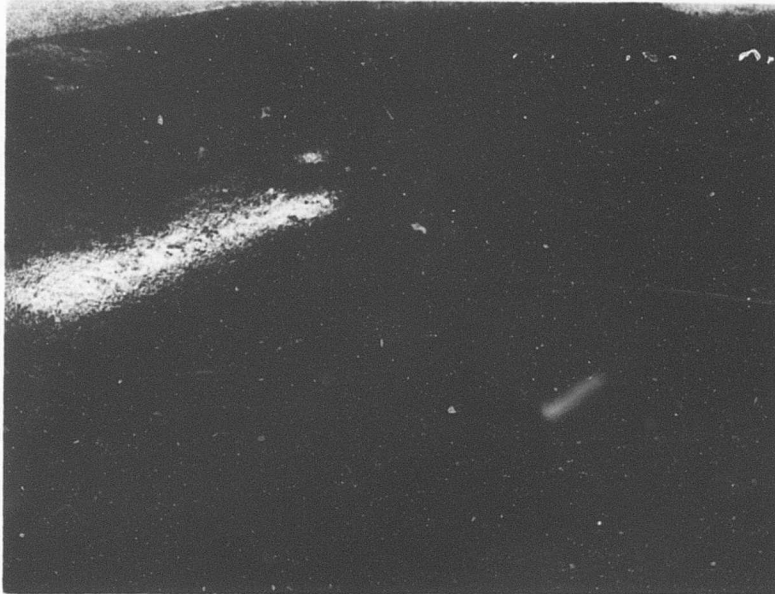
The fiberglass blade (S/N 002) withstood the impact of the steel ball with noticeably less effect than the PRD-49 (S/N003) blade. No damage was visible on the fiberglass blade after drops of up to 17 feet except for small dents resulting from the highest drops. These dents reached a maximum depth of .012 inch in the fiberglass blade and .025 inch in the PRD-49 blade. The largest dents resulted from drops close to the trailing edge. Drops on the PRD-49 blade resulted in minor fracturing of the skin at drop heights of 8 and 9 feet. In no case did the ball penetrate the skin. All damage was confined to the dented area where the ball hit. Figure 44 shows Blade S/N003 after the ball drop tests. The blades were found to have excellent resistance to ball drop impact damage.

Figure 44. Ball Drop Results -
S/N 003.
